## **Tetra Tech EM Inc.**

**Subject: Letter Report  
Cleveland Hopkins International Airport Site  
Cleveland, Cuyahoga County, Ohio  
Technical Direction Document No. S05-0101-007  
Tetra Tech Contract No. 68-W-00-129**

**PHOTOGRAPHIC LOG**

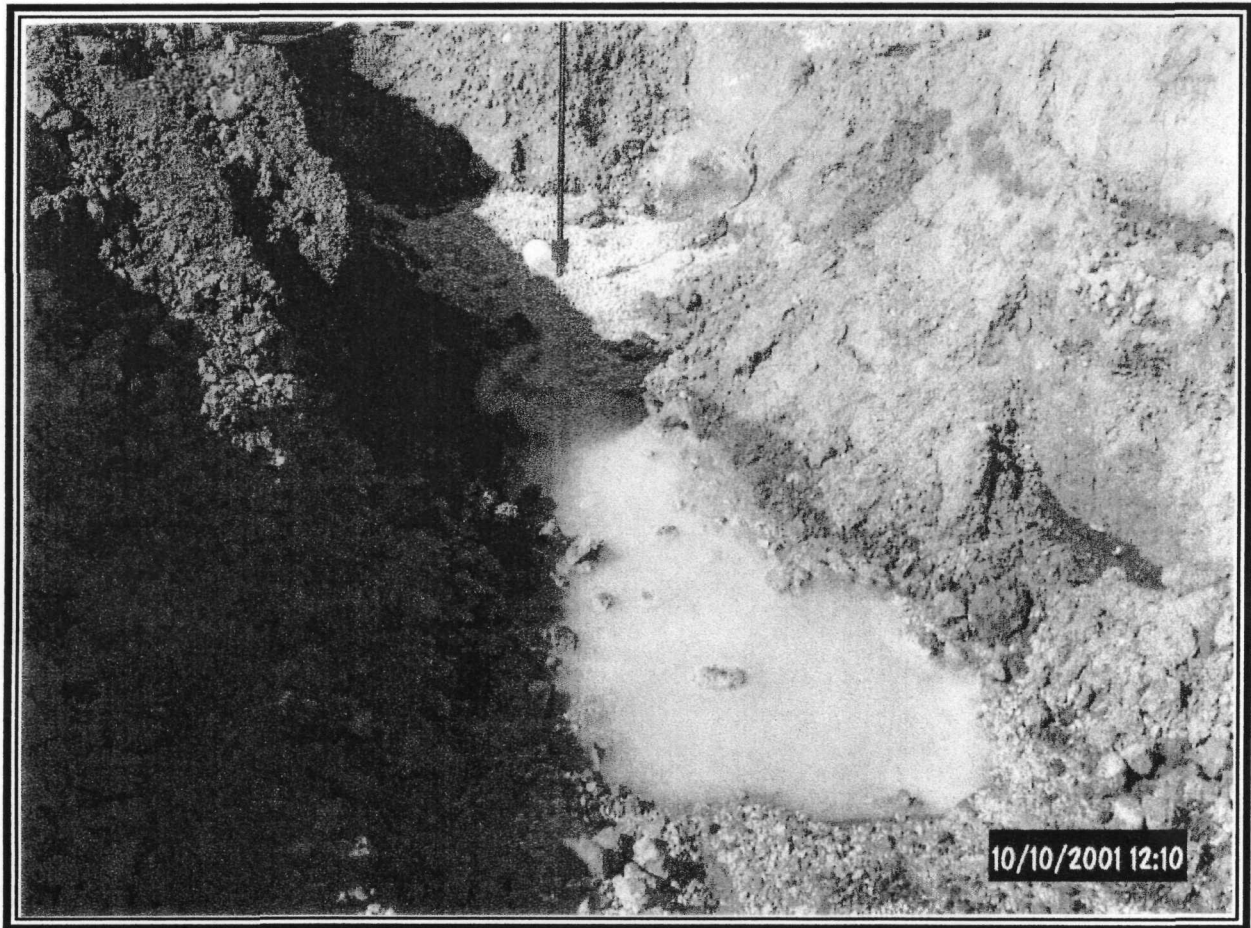
**OFFICIAL PHOTOGRAPH NO. 1**  
**U.S. ENVIRONMENTAL PROTECTION AGENCY**

**Subject:** Slag leachate in excavation area; note white discoloration

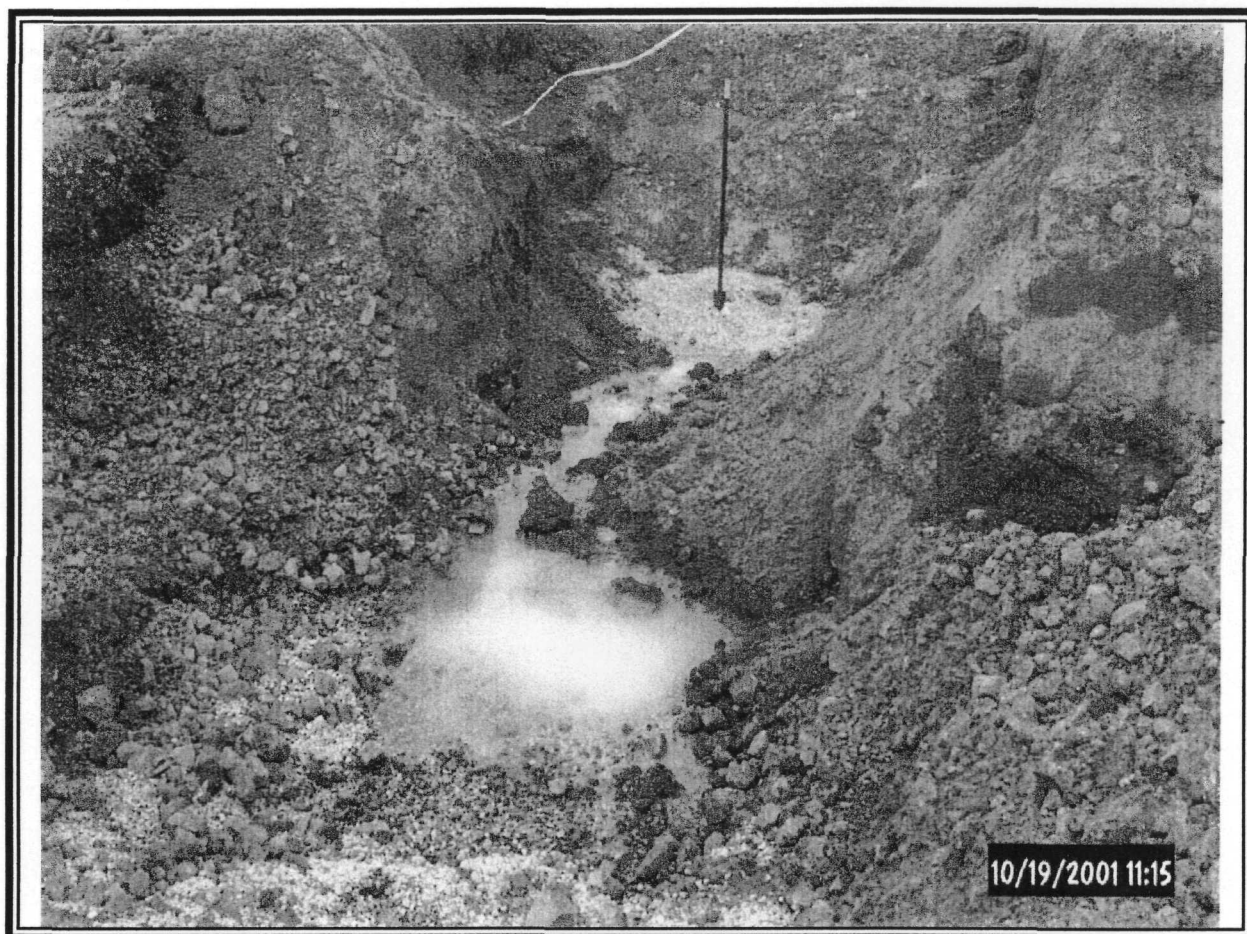
**OFFICIAL PHOTOGRAPH NO. 2**  
**U.S. ENVIRONMENTAL PROTECTION AGENCY**

**Subject:** Slag leachate in excavation area; note green discoloration

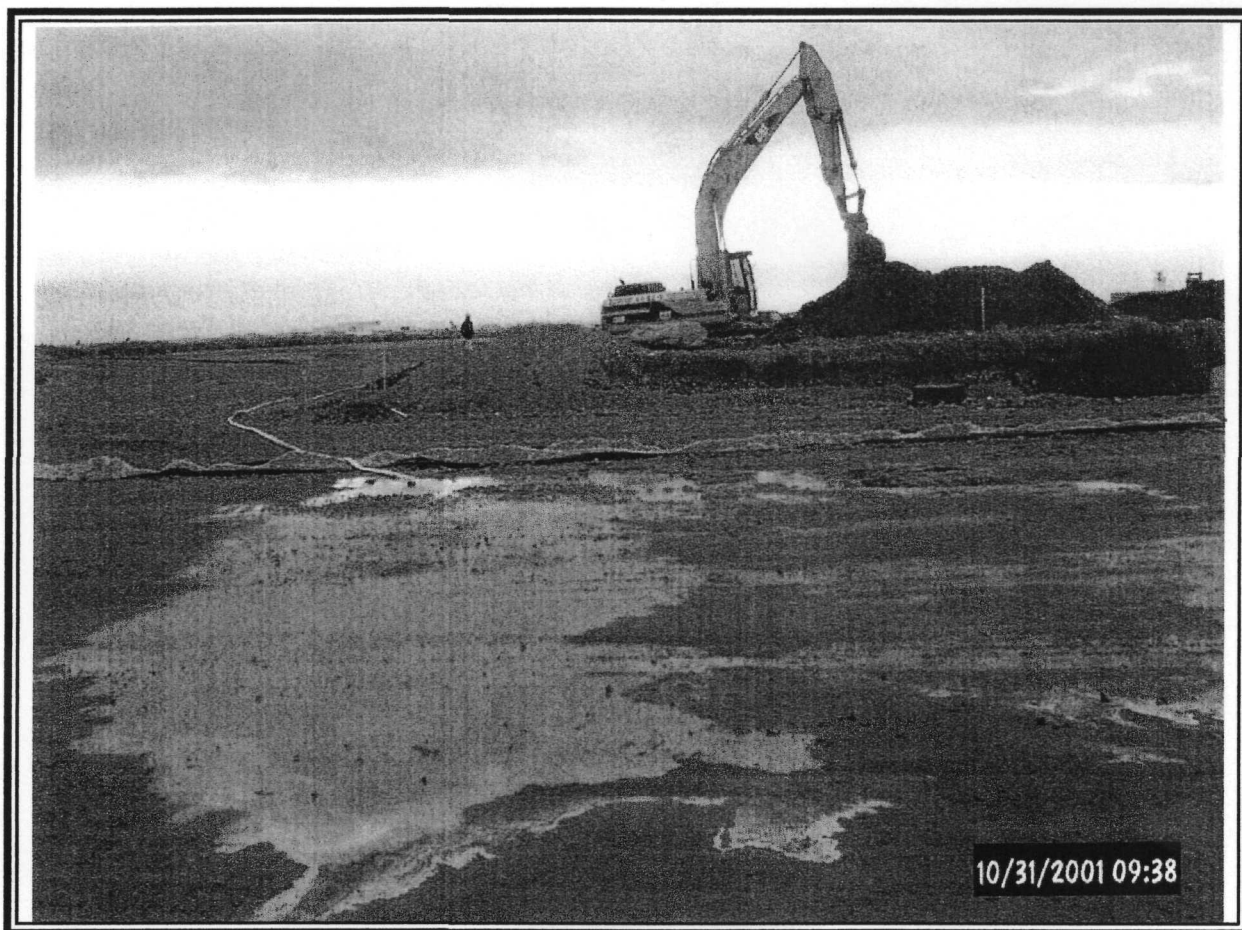
**OFFICIAL PHOTOGRAPH NO. 5**  
**U.S. ENVIRONMENTAL PROTECTION AGENCY**

**Subject:** Slag leachate being discharged on runway and taxiway from excavation area

The contractor was also observed pumping the slag leachate to the ground surface, where it was observed flowing across the proposed runway/taxiway. Photographs of these conditions were provided by Mark Villan, Airport Chief Engineer (see Enclosure 2). These conditions had ceased before START arrived on site to document conditions. According to Mark Villan, the slag leachate should have been pumped to a tanker truck and either treated or disposed of off site.

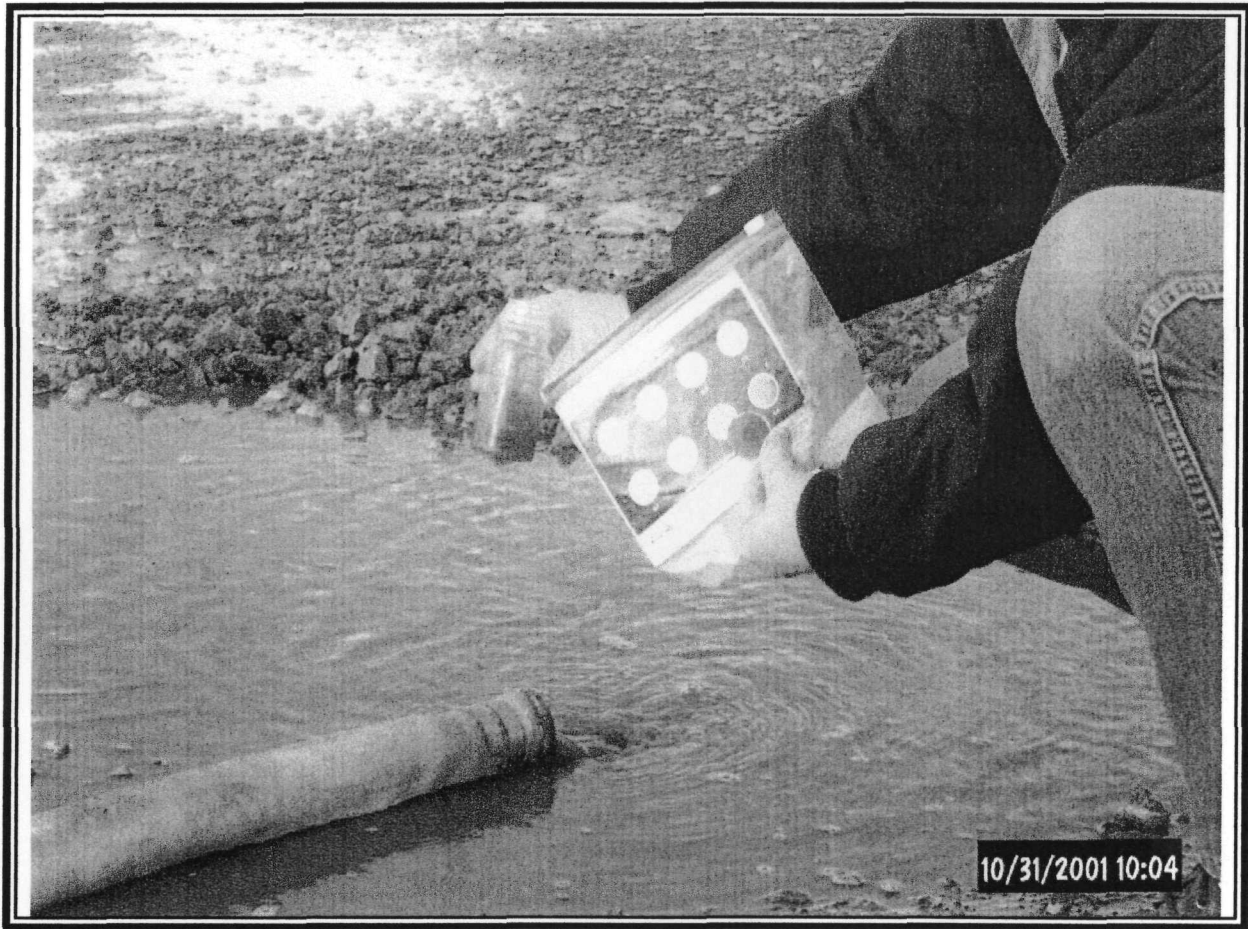
**OFFICIAL PHOTOGRAPH NO. 6**  
**U.S. ENVIRONMENTAL PROTECTION AGENCY**

**Subject:** Airport official sampling slag leachate from sump discharge hose
